Intel[®] Pentium[®] III Processor Specification Update

Release Date: November 2003

Document Number: 244453-049

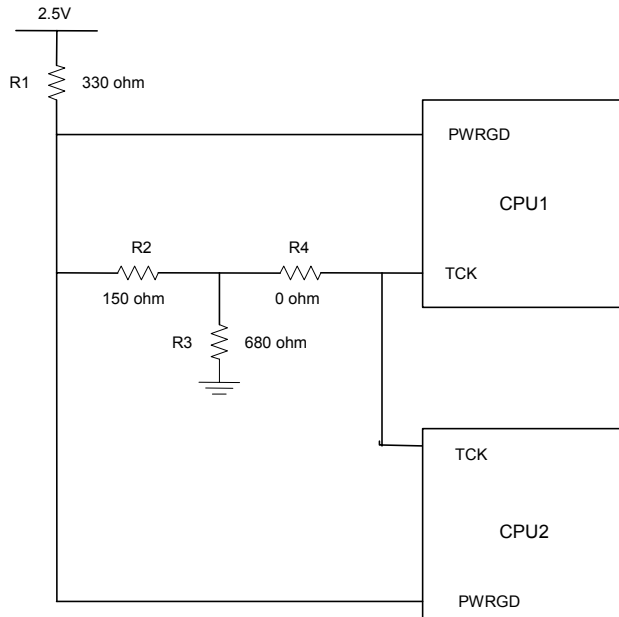
Pentium® III Processor with 512KB L2 Cache Platforms Workaround

Assumes the inputs to the CPU_PWRGD are open collector signals that are Wire-ANDed together

- The example workaround circuit assumes that the PWRGD inputs into the processors are open collector. Tying the PWRGD inputs together in a Wired-AND fashion allows each processor to receive PWRGD at the same time but at the latter of the 2 separate PWRGD assertions. If separation of the PWRGD inputs to each processor is required, extra circuitry will be required.
